FEDERAL AVIATION ADMINISTRATION
AIRWORTHINESS DIRECTIVES
SMALL AIRCRAFT, ROTORCRAFT, GLIDERS,
BALLOONS, & AIRSHIPS

BIWEEKLY 2000-07

2000-07-03 ROBINSON HELICOPTER COMPANY: Amendment 39-11657. Docket No. 99-SW-08-AD.

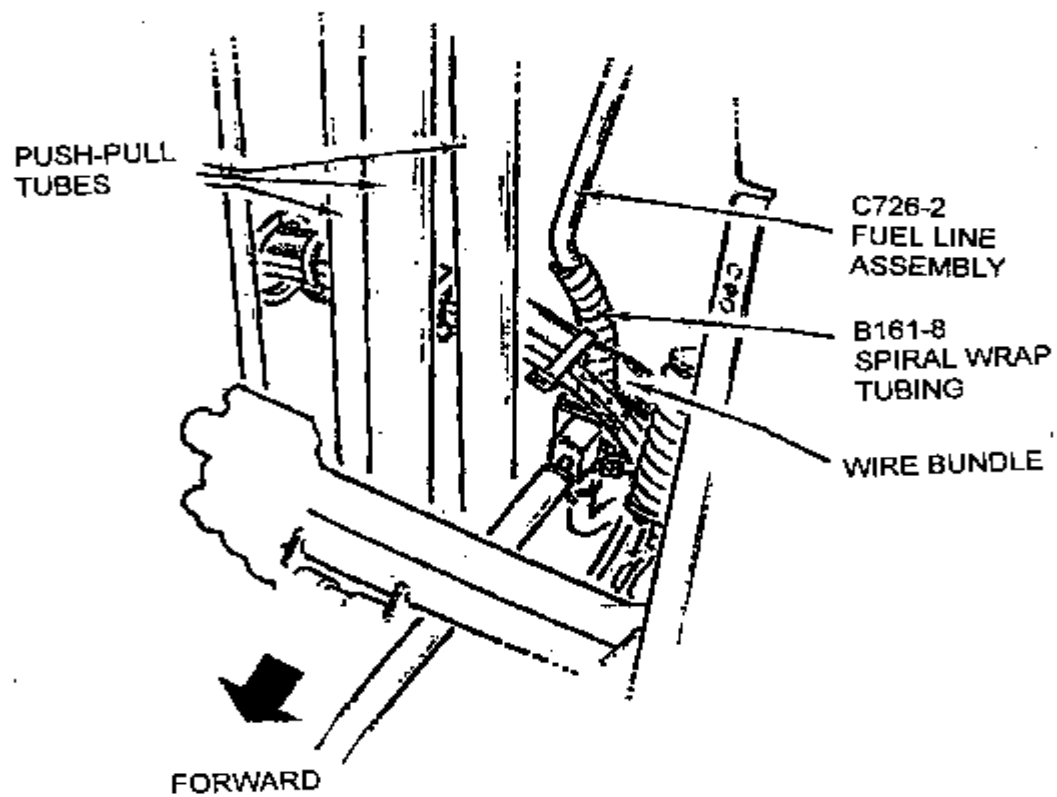
FIGURE 1

To prevent contact between the wire harness and the fuel line assembly, which could result in chafing of the wire harness and a potential fire hazard, accomplish the following:

- (a) Remove the cover, part number (P/N) C474-1, from between the rear seatbacks.
- (b) Inspect the wire harness, P/N C059, and the fuel line assembly, P/N C726-2, above the fuel shutoff valve for contact. If the wire harness contacts the fuel line assembly, inspect for chafing.
- (c) If chafing has occurred between the wire harness and the fuel line assembly, replace the fuel line with an airworthy fuel line assembly. Torque the fuel line nuts to 110-130 in-lbs. Verify that clearance exists between the fuel line assembly and the wire harness.
- (d) Install a 3-inch section of spiral wrap tubing, P/N B161-8, on the fuel line assembly as shown in Figure 1. Push the spiral wrap tubing down until it is against the fuel line fitting.
